**NASA CR - 165952
(SER-510089)**

FLIGHT SERVICE EVALUATION OF COMPOSITE HELICOPTER COMPONENTS

**FIRST ANNUAL REPORT
MARCH 1981 THROUGH APRIL 1982**

**SIKORSKY AIRCRAFT
DIVISION OF UNITED TECHNOLOGIES CORPORATION
STRATFORD, CONN.**

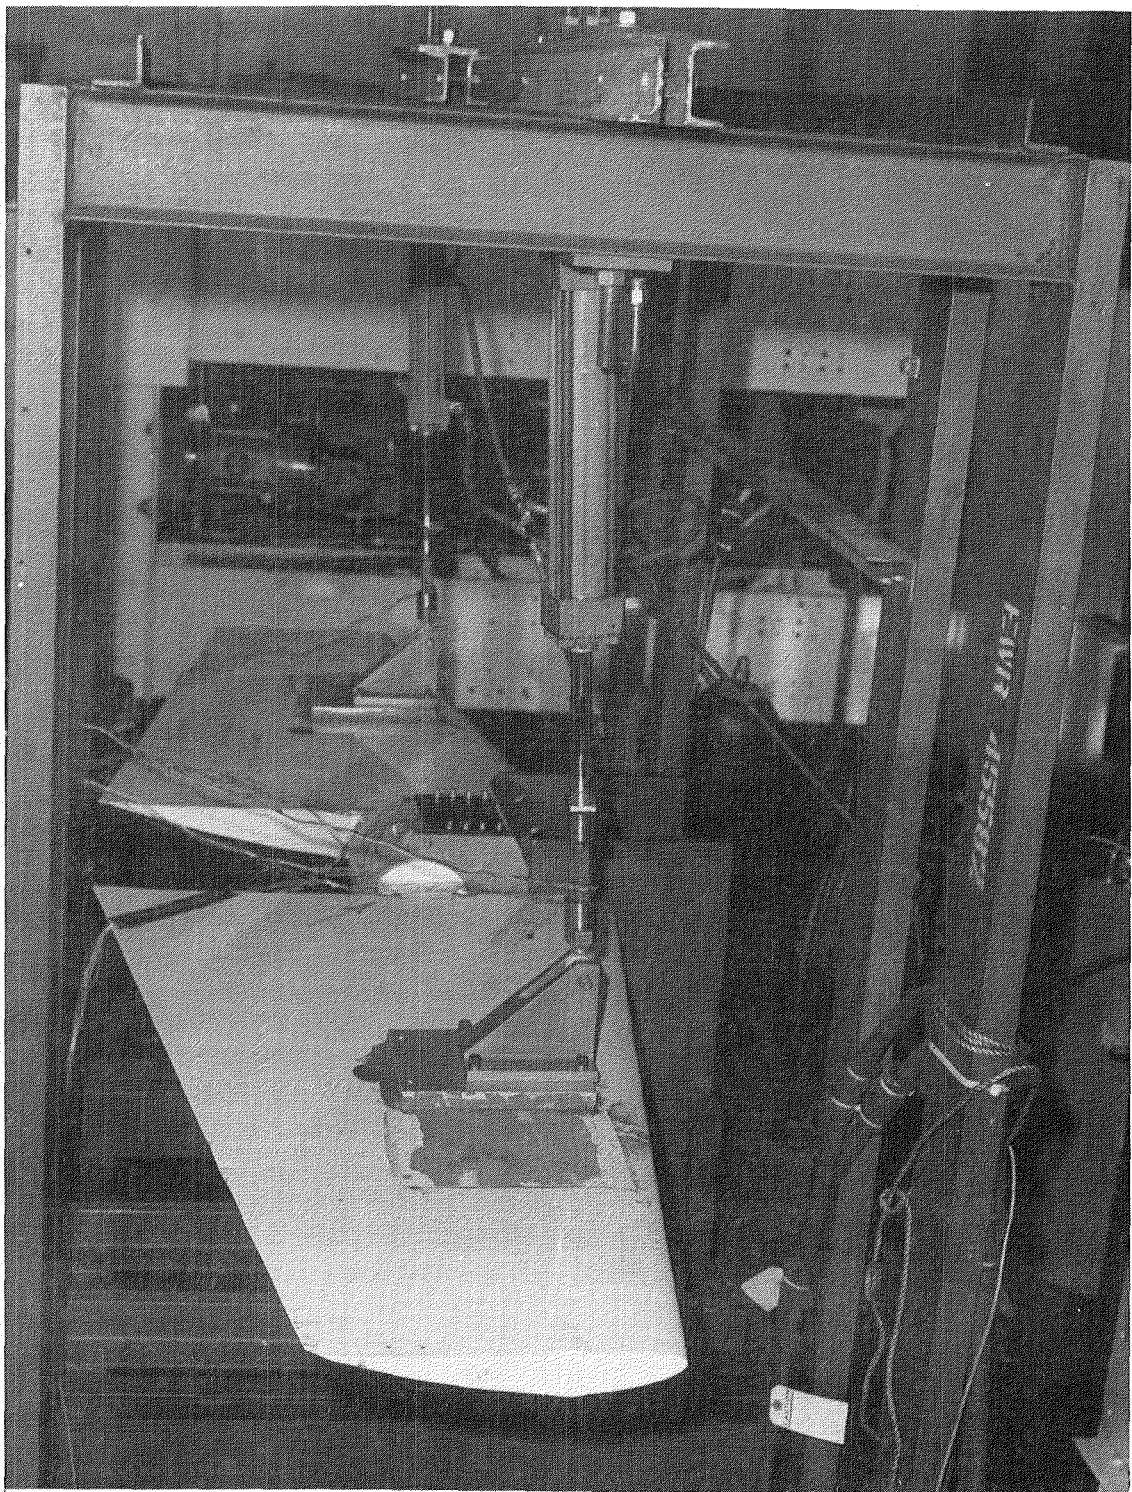
FIGURE 13. S-76 STABILIZER STATIC TEST FACILITY.

External visual inspection of the stabilizer showed a buckle in the leading edge Kevlar® splice plate at B.L. 4.5 on the left side. Upon teardown it was found that there was a loss of shear transfer of the composite material to the metal honeycomb. The structural box is designed to have redundant shear path so that shear loadings can be resisted by the honeycomb or the Kevlar box structure. The indication is that at 220% of DLL the shear transferred to the Kevlar box and eventually buckled the sidewall splice plate. However, the combination of some remaining shear capability in the Kevlar box provided the structural capability for at least 150% limit load with reduced rigidity. A schematic representation of the modes is shown in Figure 15.

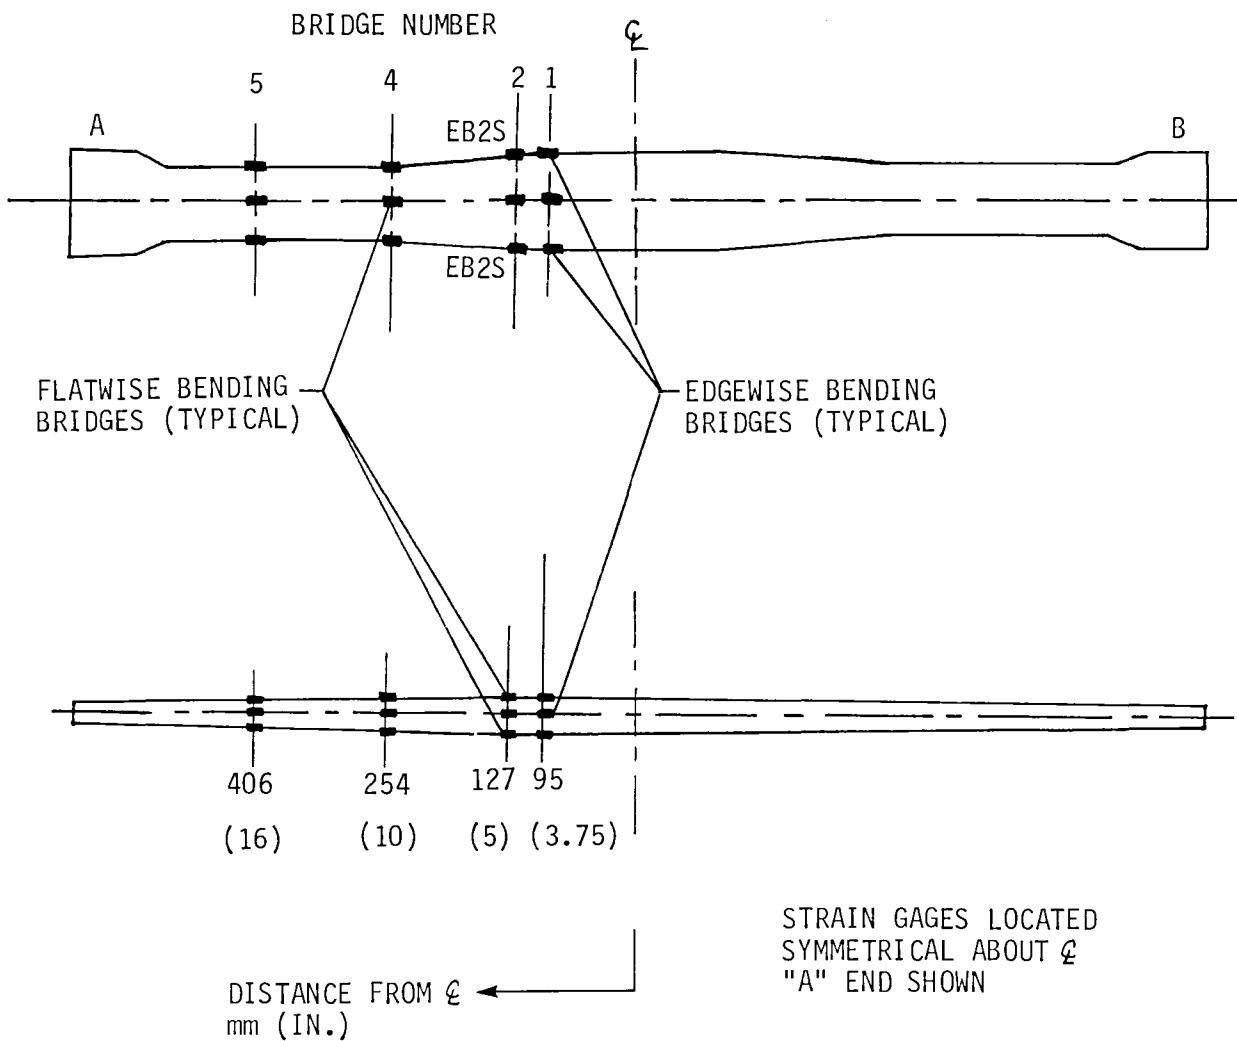
FIGURE 19. S-76 SPAR STRAIN GAGE LOCATIONS.

The EB2S strain gage locations were selected since previous testing resulted in fractures at that section (station 5, Figure 19).

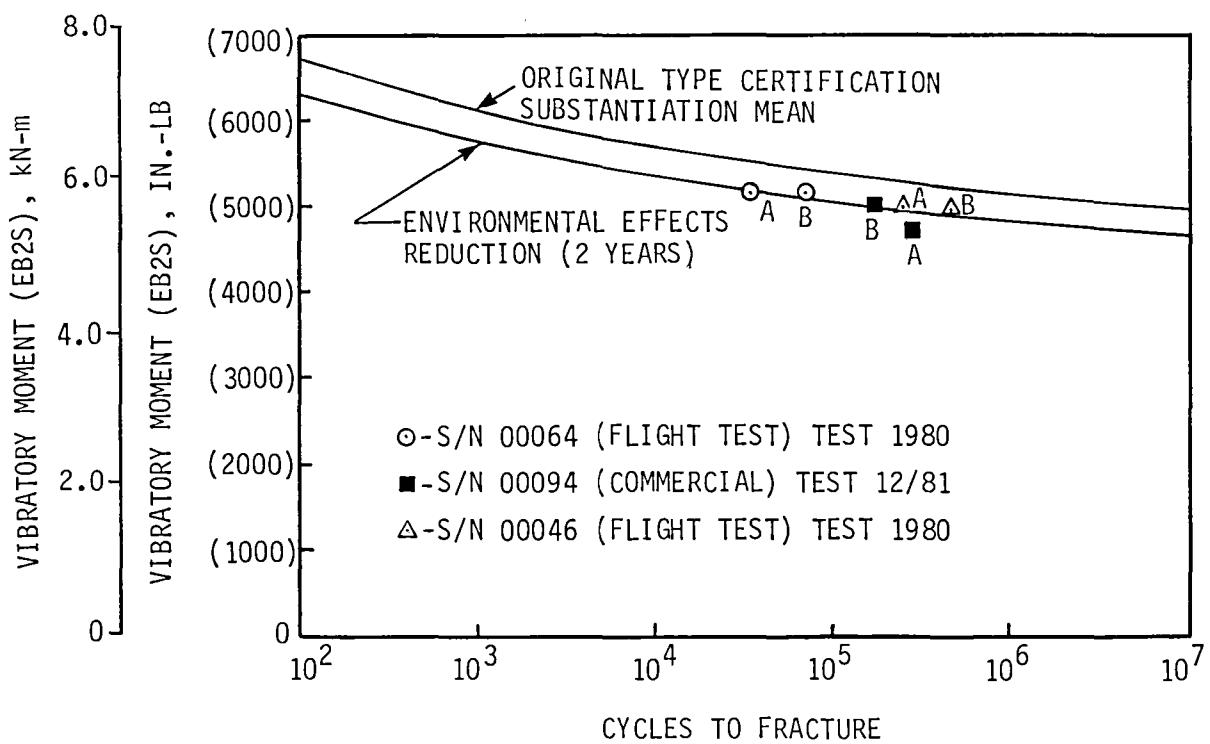
FIGURE 20. MOMENT-FATIGUE CYCLE RESULTS FOR S-76 TAIL ROTOR SPARS.

The tail rotor spars, as designated in Table IX, were all returned from humid areas. The first two (S/N 00046 and 00064) are from Sikorsky flight test helicopters and the third (S/N 00094) is from a commercial operation. The fatigue test results are plotted in Figure 20. The data shows a small but consistent reduction in fatigue strength for the 2 to 2½ years in-service exposed blades when compared to the mean load-cycle curve of the blades tested for type certification (room temperature dry).

The edgewise cyclic moment is the dominant factor in the fatigue of the tail rotor spar. This moment is designated as (EB2S) in Figure 20 and is the variable in the moment cycle curve. The other loads, flatwise, torsion induced by cyclic pitch change and the steady centrifugal are also applied during the fatigue tests.

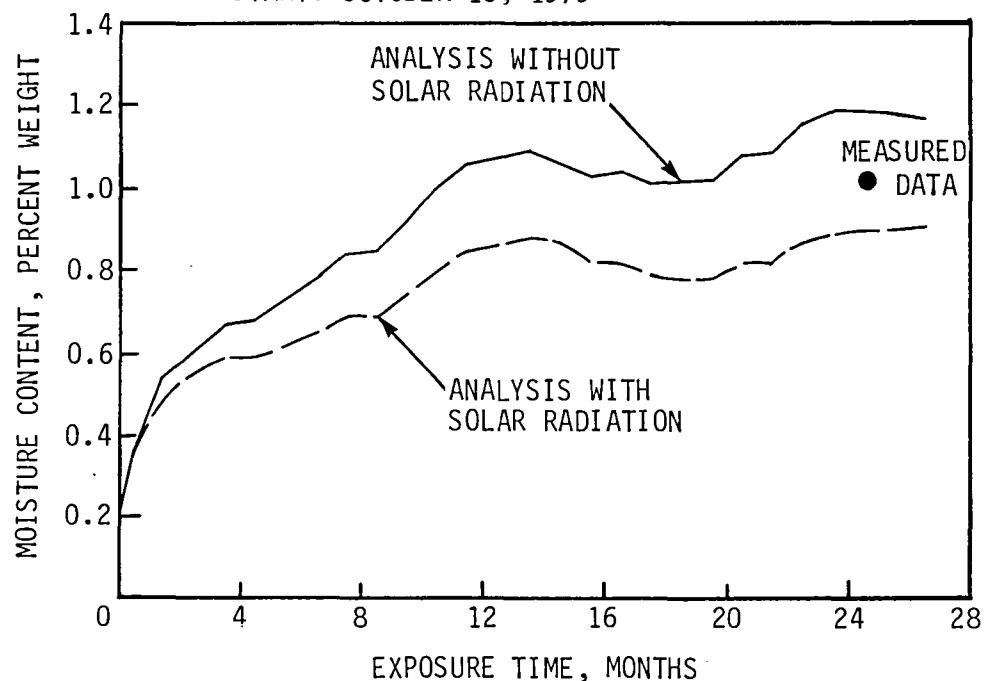
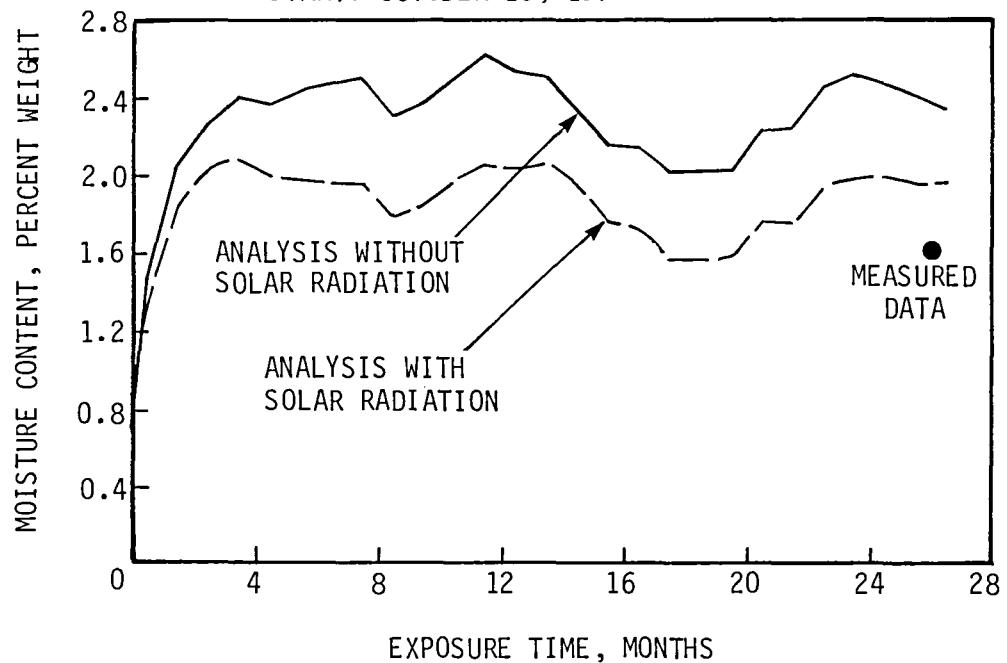
FIGURE 23. MOISTURE ABSORPTION FOR GRAPHITE/EPOXY PANELS, WPB.

FIGURE 25. MOISTURE ABSORPTION FOR KEVLAR/EPOXY PANELS, WPB.

In general, the exposed panels appear to absorb less moisture than would be predicted by an environmental analysis using ambient RH only. A comparison shown in Figures 23 and 25 for the West Palm Beach Region panels shows absorbed moisture is significantly less than would be predicted by using ambient RH only. The reduction is close to the 24 percent projected in the study of Reference (8) for graphite/epoxy and but even more for Kevlar/Epoxy. The results at the Stratford location (a less humid region) are mixed and kevlar/epoxy moisture is less than predicted. It should be noted that snow is a factor at the Stratford location and that effect is not accounted for in the environmental analysis.

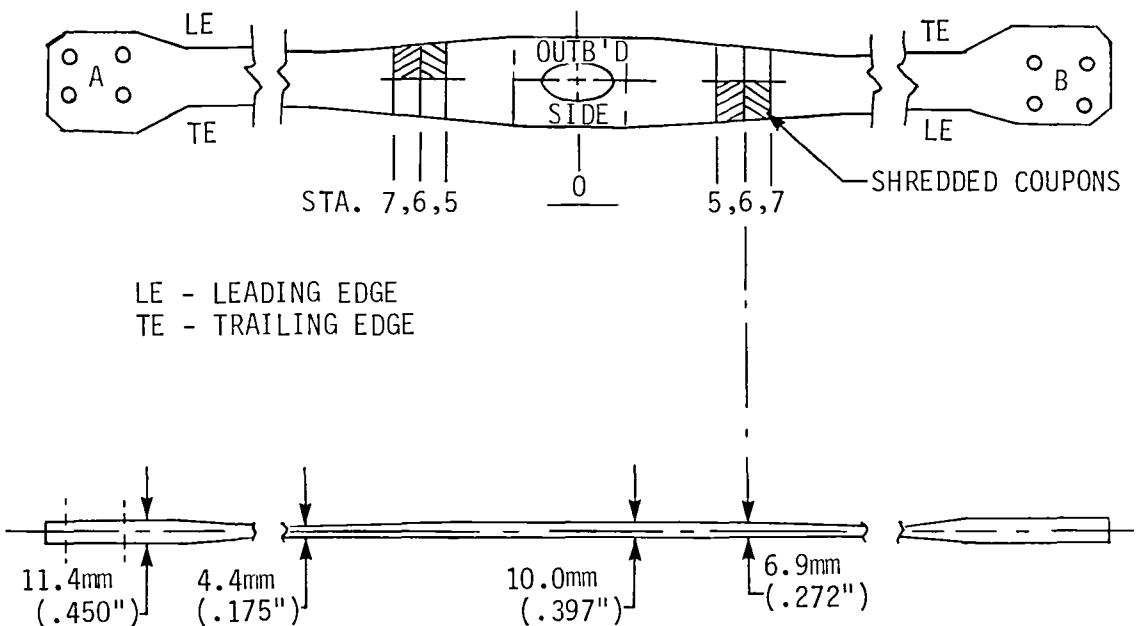
FIGURE 27. S-76 TAIL ROTOR SPAR - LOCATION OF MOISTURE MEASUREMENT COUPONS.

The results of the spar coupon moisture desorption tests are listed in Table XIV. The average moisture content for Station 6, nearest the fracture zone, is .26% weight.

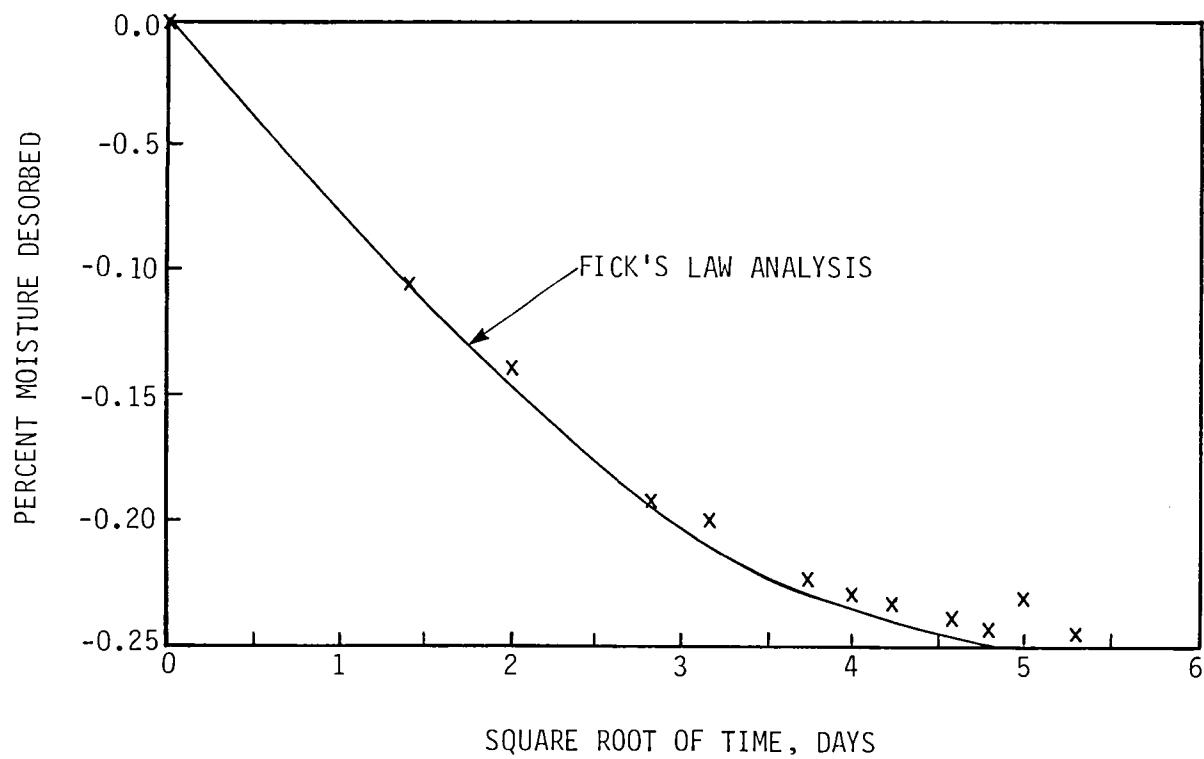
FIGURE 29. DESORPTION TIME HISTORY OF COUPON FROM TAIL ROTOR SPAR,
S/N 00094. (STATION 6-7 L-E, END B).

The desorption time history of the coupon for the B end at Sta. 6-7 leading edge is typical and shown in Figure 29. The projected moisture absorbed is .26 percent weight. Due to the thickness of the tail rotor spar the initial dry condition at time of certification is considered to be near zero. Stabilizer desorption time history is presented in Figure 30 for Kevlar/epoxy.

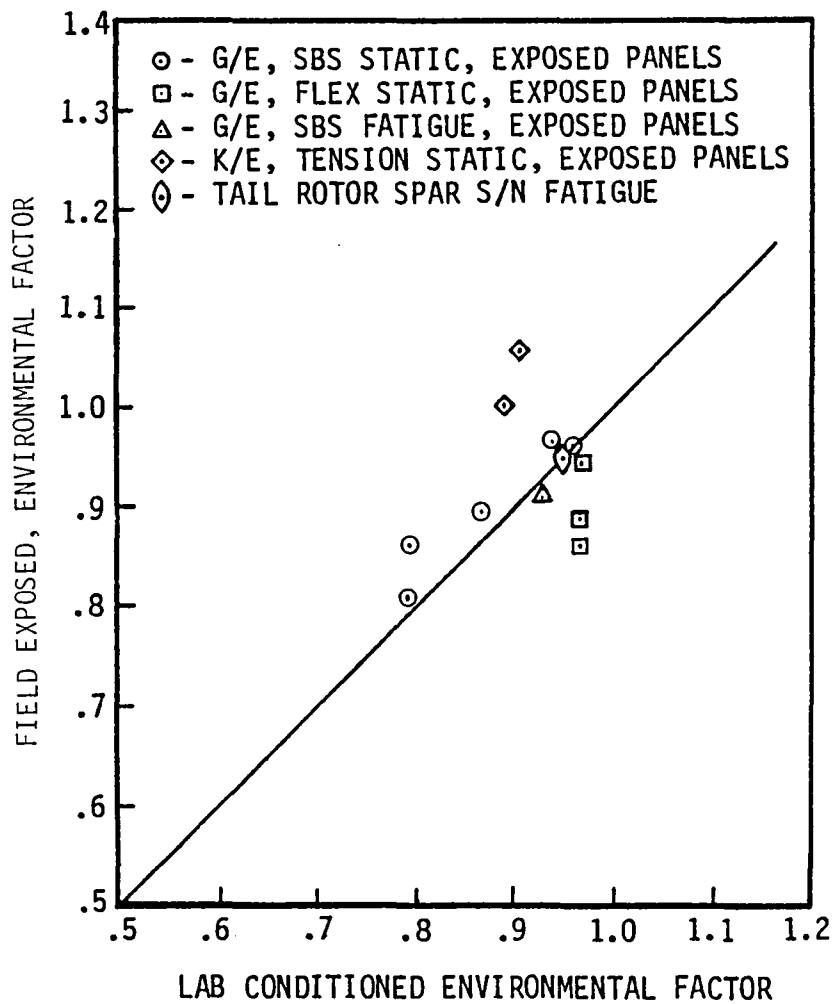
FIGURE 31. COMPARISON OF ENVIRONMENTAL FACTORS FOR FIELD EXPOSED AND LABORATORY CONDITIONED COUPONS.

A comparison of environmental factors derived from lab conditions and field exposure is presented in Figure 31.

The environmental factor (E.F.) is defined as the ratio of conditioned (field or lab) strength to the RTD strength. Figure 31 compares the field exposed E.F. with those determined from accelerated lab conditioning.

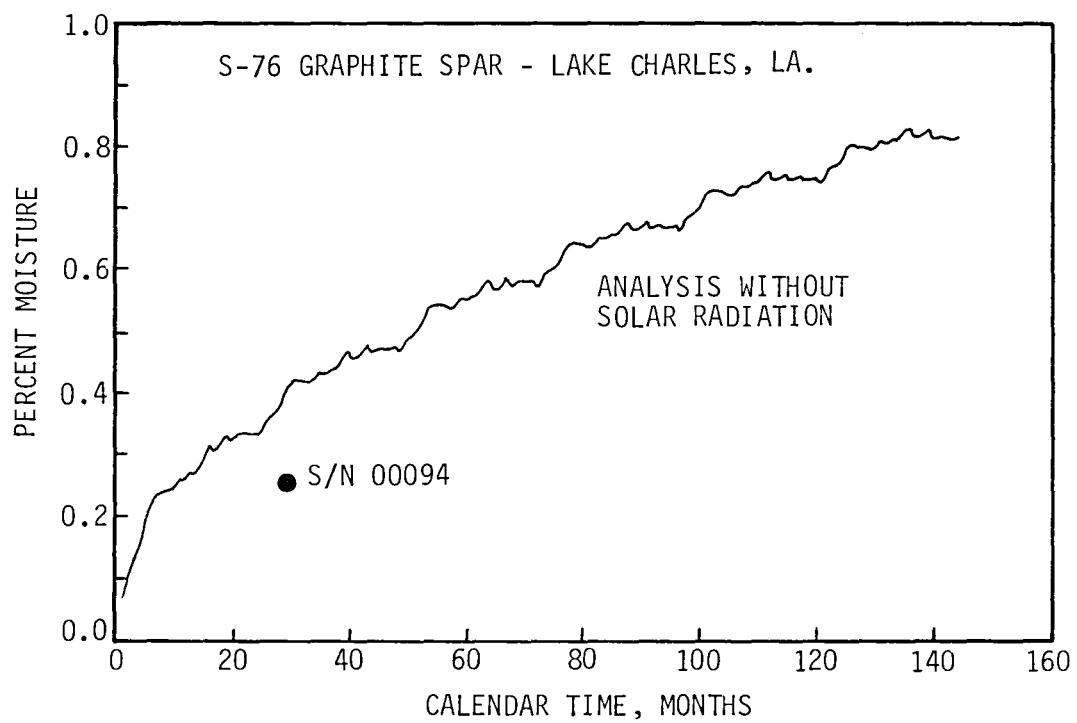
FIGURE 32. GRAPHITE TAIL ROTOR SPAR MOISTURE ANALYSIS, GULF COAST REGION.

Due to the spar thickness (about 6.35mm, .25 inches) the moisture absorption is a slow process under service conditions. The projected moisture absorption time history (without solar radiation and convection) is presented in Figure 32. The actual measured moisture for S/N 00094 is, as expected, far below the conservative analysis.

The analysis indicates that the next spars to be fatigue tested (calendar time at least 36 months) should have only a small moisture increase over spar S/N 00094. Thus the next program test will serve to confirm the moisture content results and the effects of calendar time and flight hours.
